CASE STUDY

MAGNETIC COMPASS REPAIR

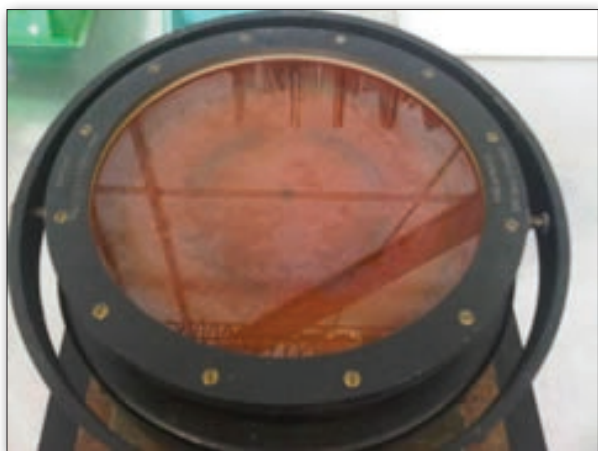
STEP 1

Inside of the compass bowl is dirty with rust because of the steel filler screw place by a third party.

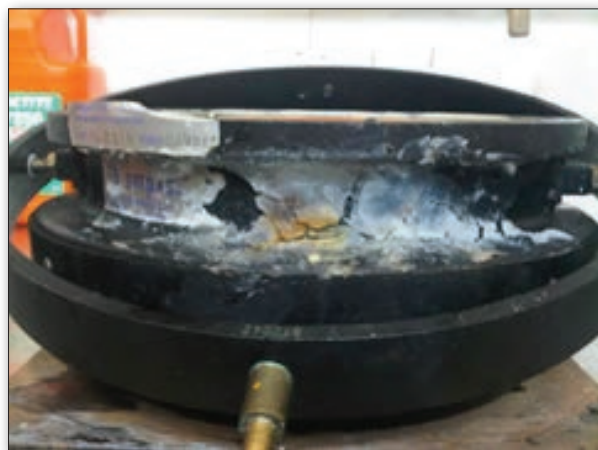
STEP 2

Silicone is found on around the filler screw. This was most likely applied by a third party to avoid any leaks.

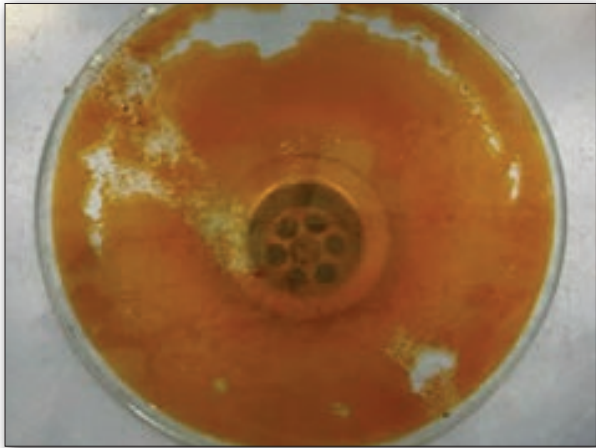
| STEP 3

At this point, we start to dismantle and clean the compass, starting with the top glass and bezel ring which has a layer of rust on it.

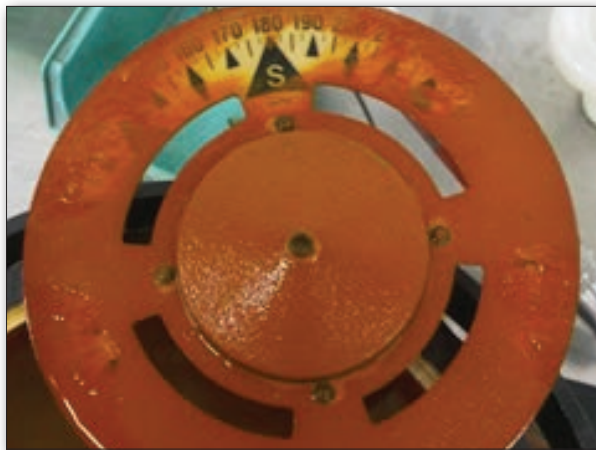
| STEP 4

After removing the top glass from the compass, you can see the dirty card and float caused by rust from the steel filler screw.

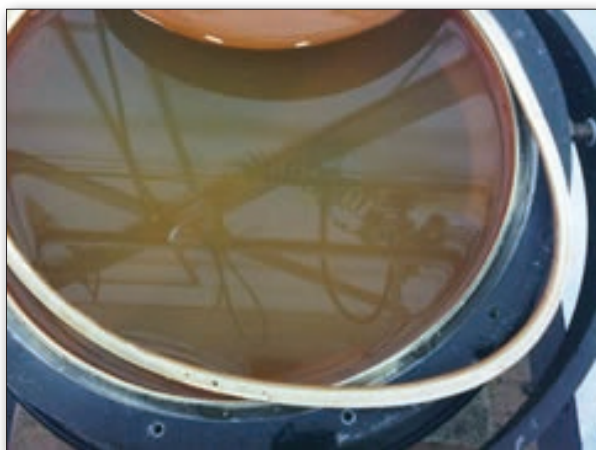
| STEP 5

The white rubber gasket is flattened and hard. This will be replaced at a later stage of the repair to seal the compass when finished.

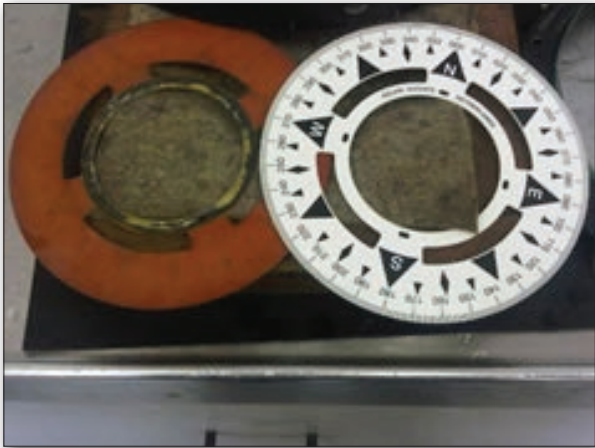
STEP 6

On the left side you can see the old card minus the float and on the right side you can see a new card.

The old card could not be cleaned because the dye from the rust could not be removed.

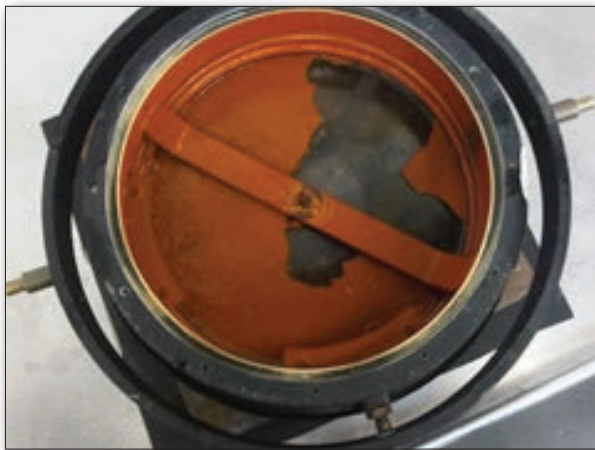
STEP 7

The compass bowl needs to be stripped of paint and sandblasted as the dye from the rust has stained the paint with a brown colour.

After the removal of the liquid the bottom glass can be removed and then the inside of the compass bowl is cleaned.
