CASE STUDY

MAGNETIC COMPASS REPAIR

This compass has become faulty as a result of a steel filler screw being used as a replacement to a stainless steel screw. As a result, the steel screw corroded and contaminated the damping liquid, producing a rusty colour dye and making it near impossible to read the compass headings.

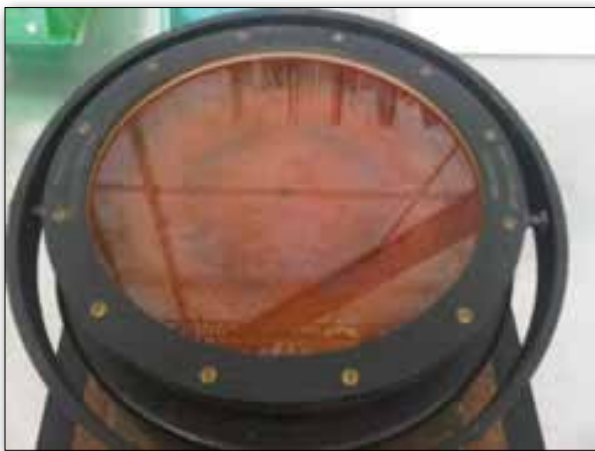
STEP 1

The inside of the compass bowl is dirty with rust due to the steel filler screw placed there by a third party.

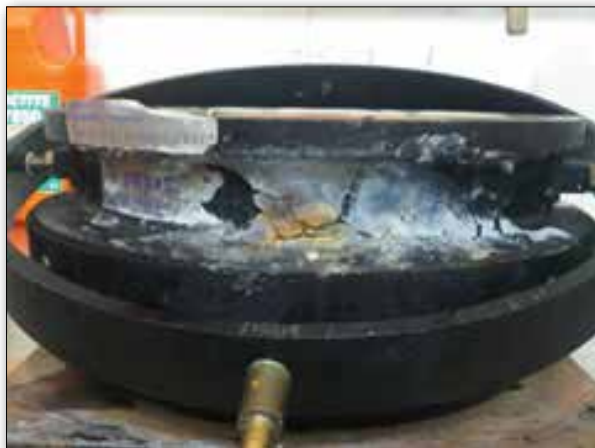
STEP 2

Silicone is found around the filler screw. This was most likely applied by a third party to avoid any leaks.

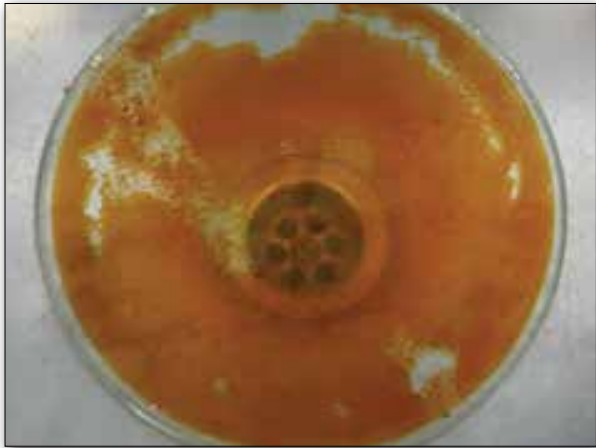
STEP 3

At this point, we begin to dismantle and clean the compass, starting with the top glass and bezel ring which has a layer of rust on it.

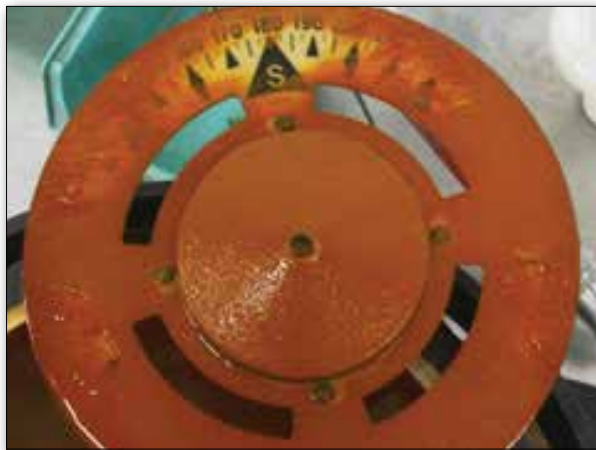
STEP 4

After removing the top glass from the compass, you can see the dirty card and float caused by rust from the steel filler screw.

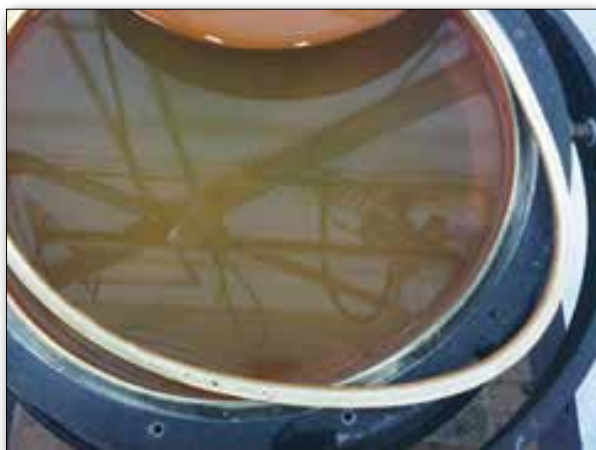
STEP 5

The white rubber gasket is flattened and hard. This will be replaced at a later stage during the repair to seal the compass when finished.

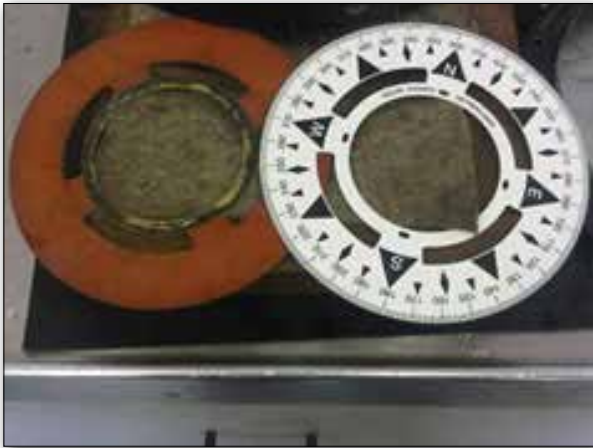
STEP 6

On the left side you can see the old card minus the float, and on the right side you can see a new card.

The old card could not be cleaned because the dye from the rust could not be removed.

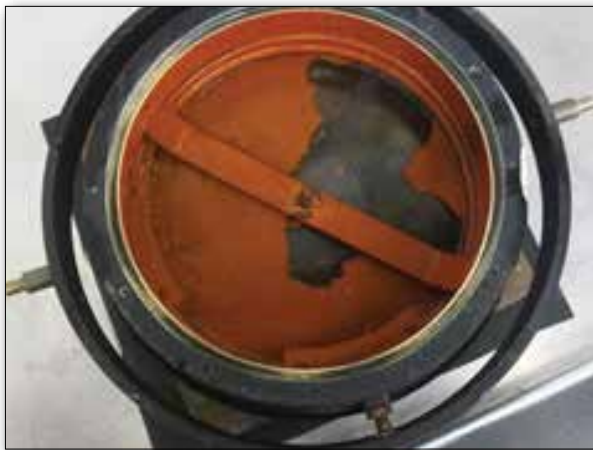
STEP 7

After removal of the liquid, the bottom glass can be removed, and then the inside of the compass bowl can be cleaned.

The compass bowl needs to be stripped of paint and sandblasted, as the dye from the rust has stained the paint with a brown colour.

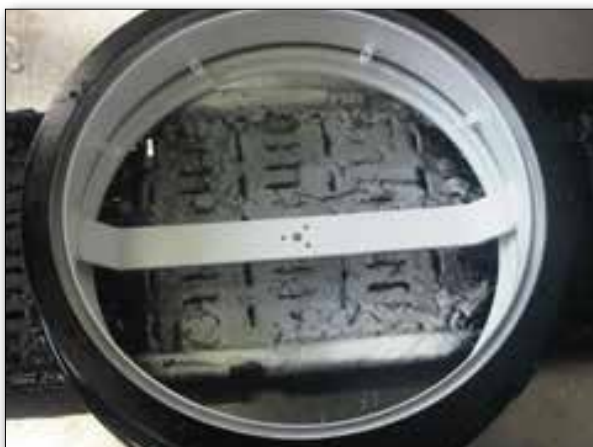
STEP 8

This is the result after cleaning, dismantling, sandblasting and repainting the complete compass bowl.

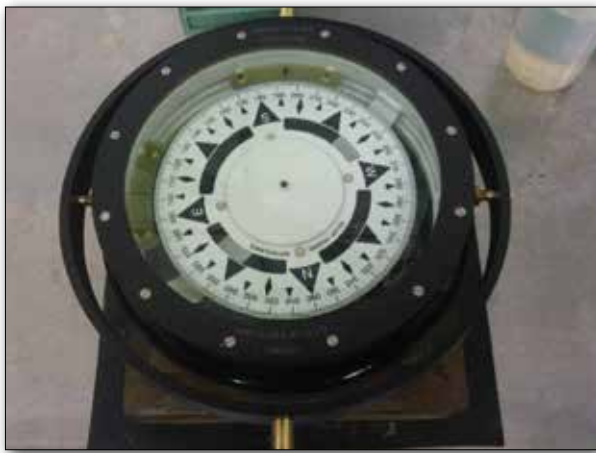
STEP 10

Final result of the overhauled magnetic compass.

The compass is now ready to be transported to the vessel along with its NSI certificate, valid for 2 years, and ready for navigation.
